OPERATION PLUMBBOB

NEVADA TEST SITE
MAY-OCTOBER 1957

Project 30.7

TEST OF GERMAN UNDERGROUND
PERSONNEL SHELTERS

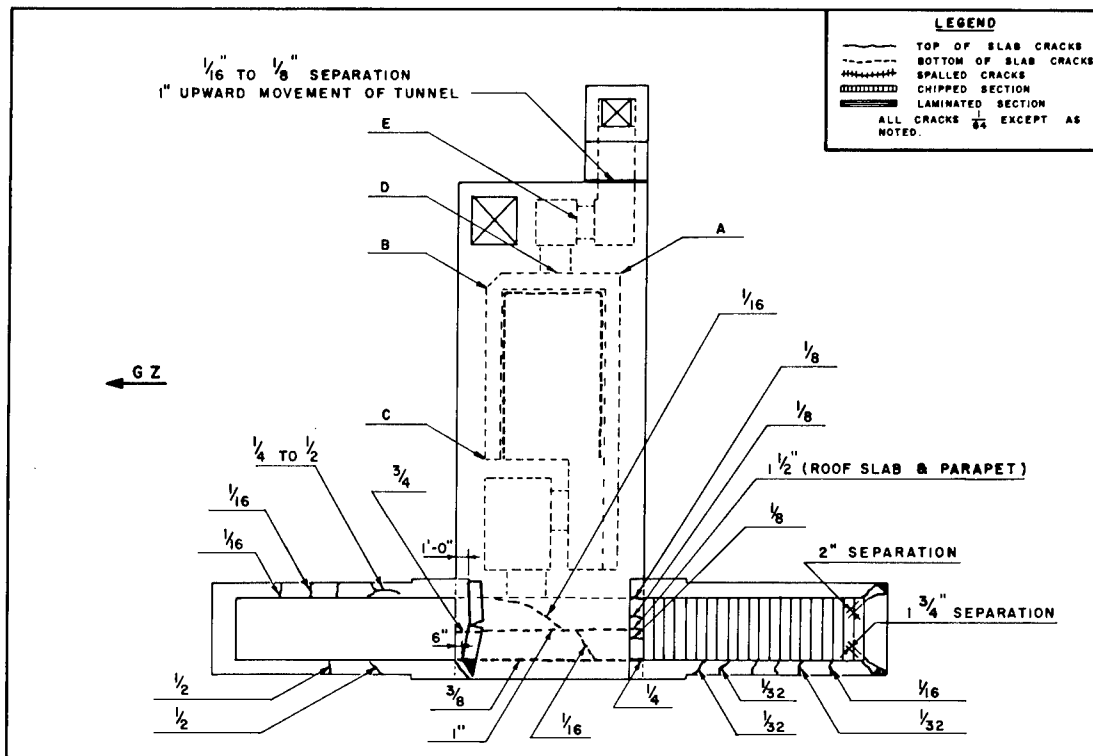
(c) *Main Chamber*. Hairline cracks were formed at the intersection of the roof slab and the haunches along the rear and side walls of the main chamber. The intersection of the walls located at points A, B, and C of Fig. 3.1 had continuous hairline cracks the full height of the walls. Diagonal hairline cracks were formed at the four corners of the door opening located at point D. Numerous transverse and longitudinal hairline cracks were produced on the floor slab of the main chamber. No cracks were present in the floor slab of the main chamber adjacent to the main seal door.

The crack patterns for structure RAa are shown in Figs. 3.1 to 3.3. Appendix C contains the postshot dynamic analysis of the roof slab of shelter RAa. The analysis indicates that only minor cracking was expected under the applied blast load.

(d) *Exit Chamber*. As in the main chamber, diagonal cracks were formed at the four corners of the door opening located at point E, Fig. 3.1. No structural damage was evident in the roof and floor slabs.

Fig. 3.1—Roof-slab crack pattern (structure RAa).

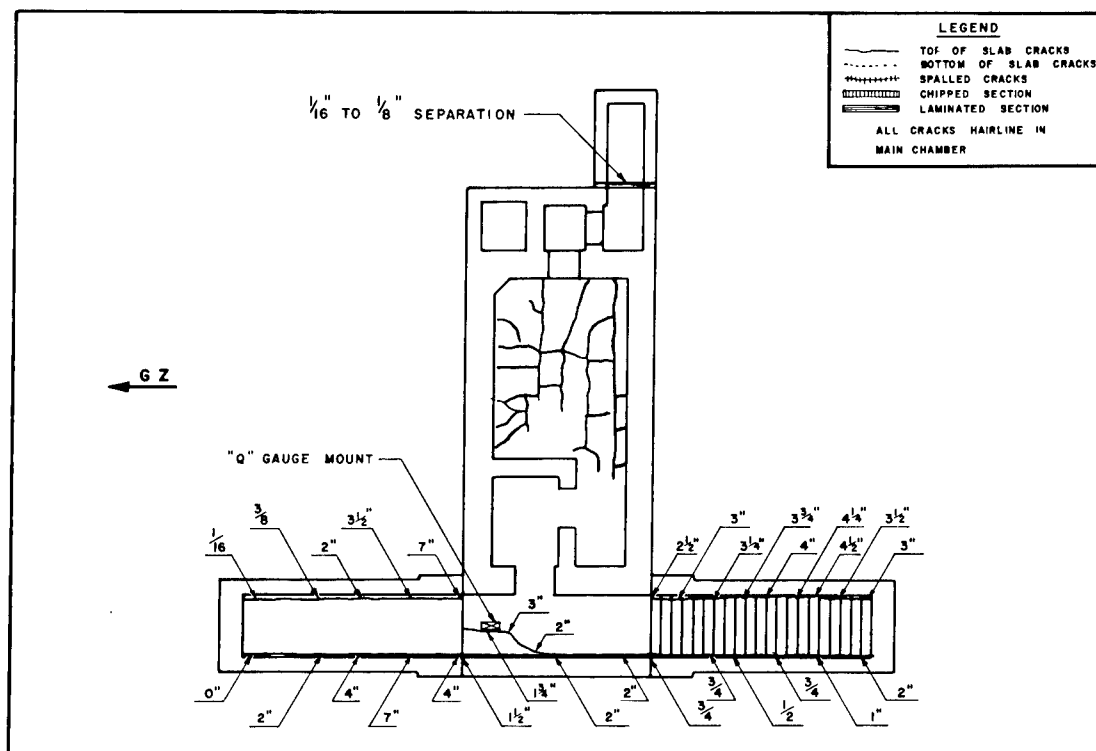
Fig. 3.2—Floor-slab crack pattern (structure RAa).

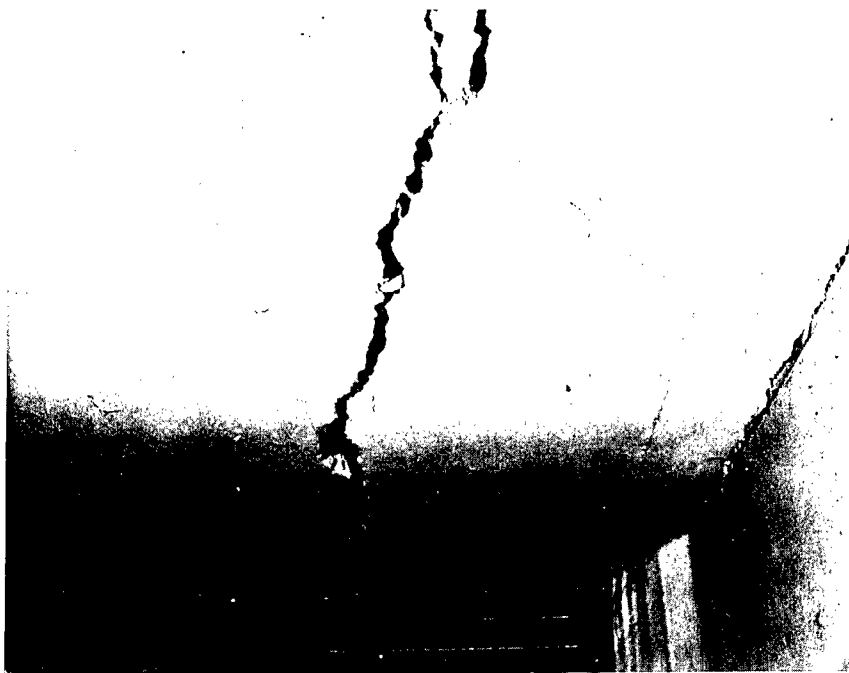
Fig. 3.9—Cracks along center of landing roof slab and at intersection with exterior wall (structure RAa).

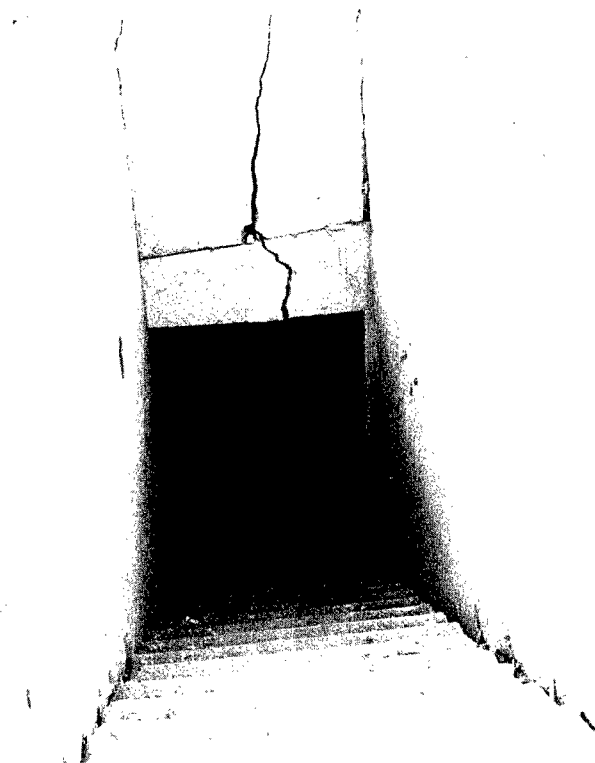
Fig. 3.11—Cracks in parapet wall and end of landing roof slab at entrance facing away from GZ (structure RAa).

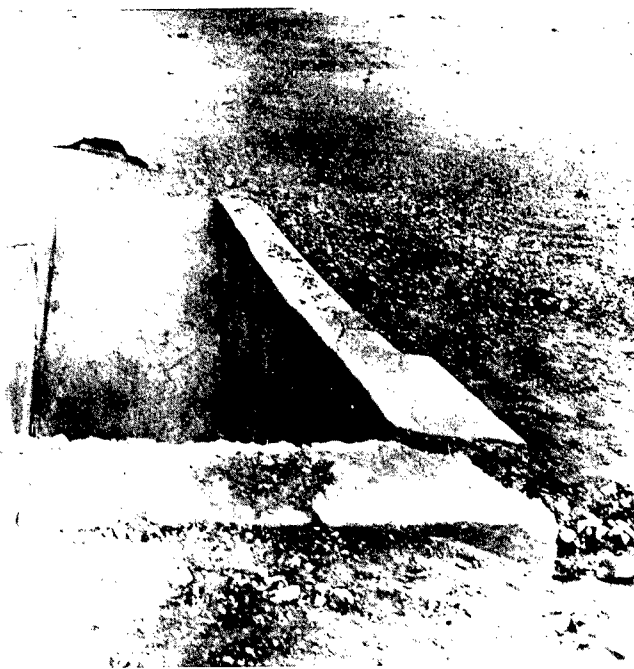
Fig. 3.13—Blast damage to ramp walls of entrance facing GZ (structure RAa).

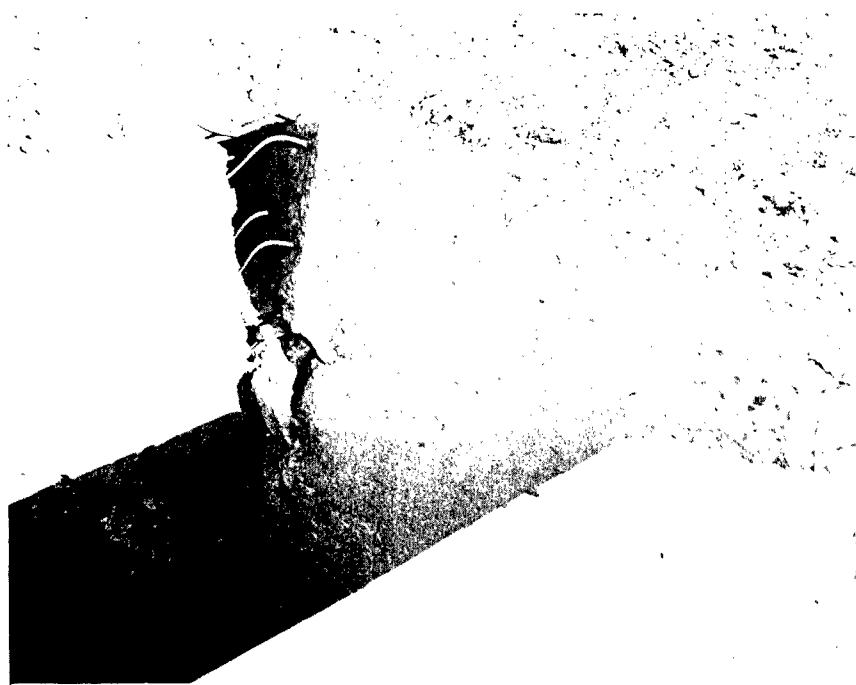
Fig. 3.15—Blast damage at intersection of interior wall and parapet wall facing toward GZ. (structure RAa).

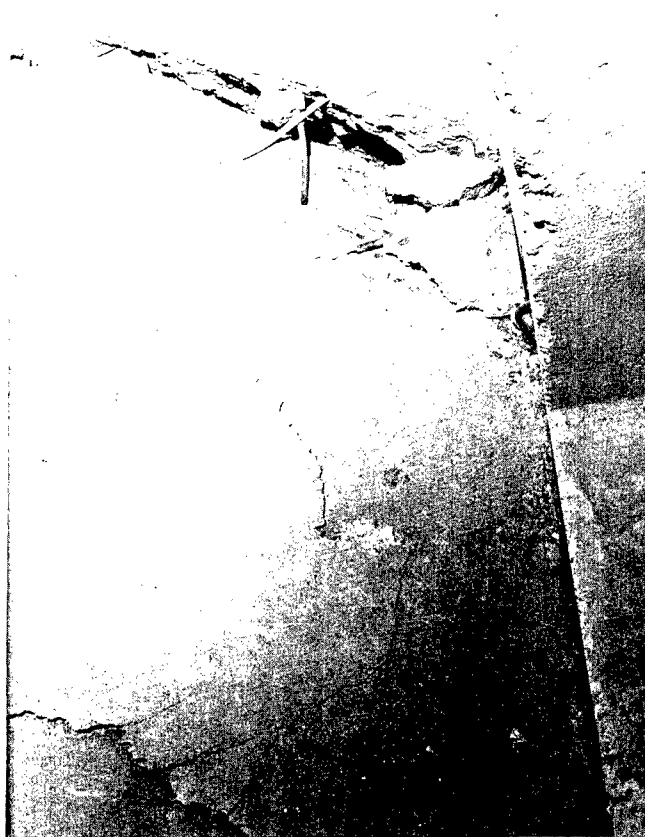
Fig. 3.16—Detail of cracks and spalled and laminated area in interior wall at contraction joint at entrance facing toward GZ (structure RAa).

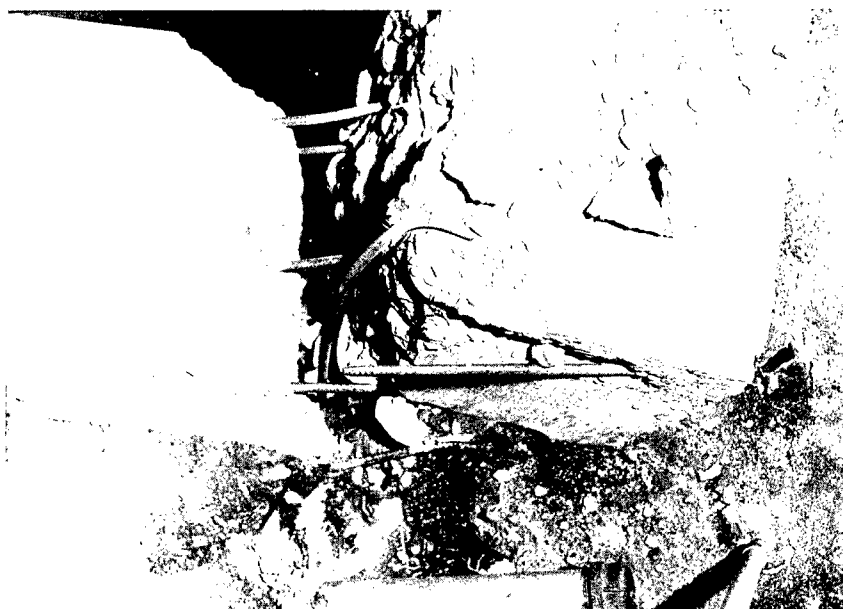
Fig. 3.17—Detail of crack at intersection of exterior wall and parapet wall facing toward GZ (structure RAa).

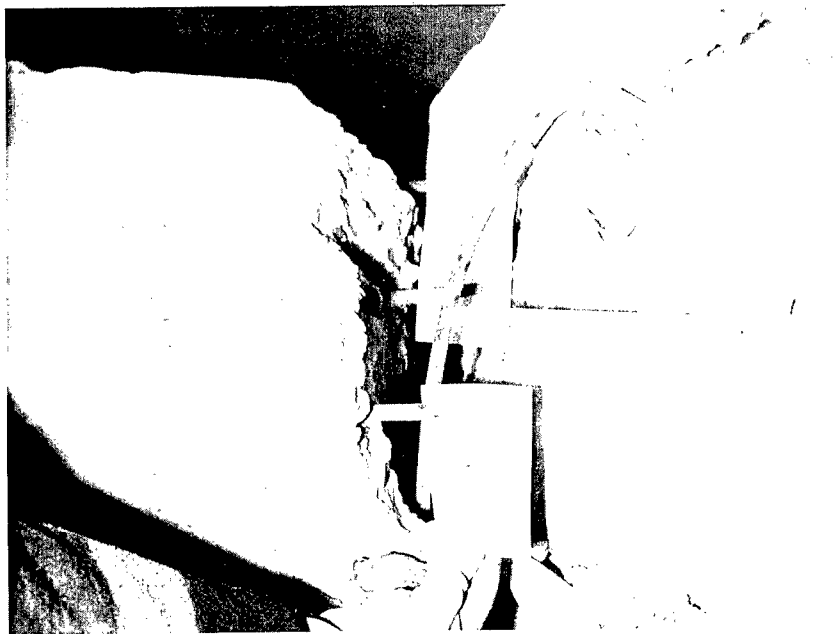
Fig. 3.18—Detail of necked-down reinforcement at intersection of exterior wall and parapet wall facing toward GZ (structure RAa).

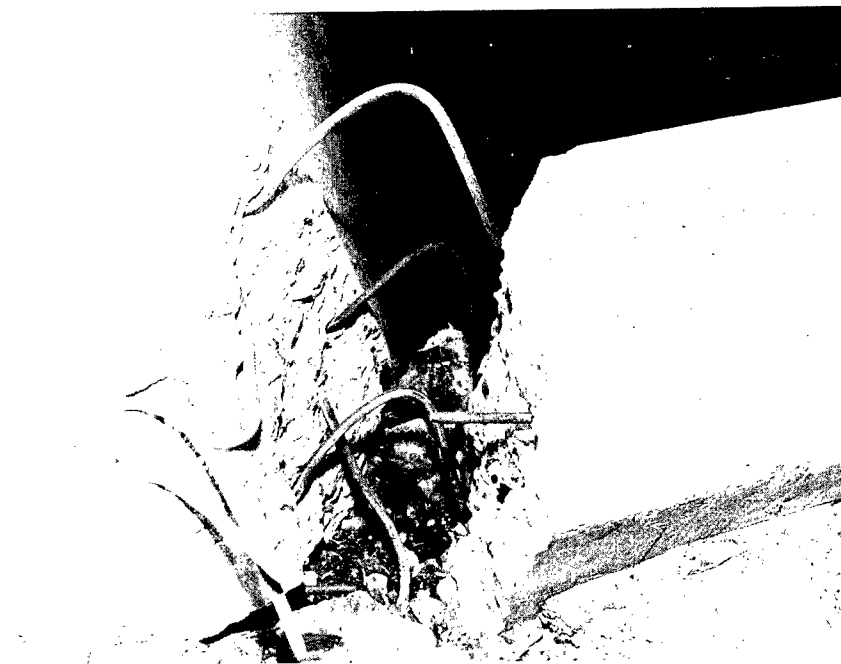
Fig. 3.19—Detail of crack at intersection of interior wall and parapet wall facing toward GZ (structure RAa).

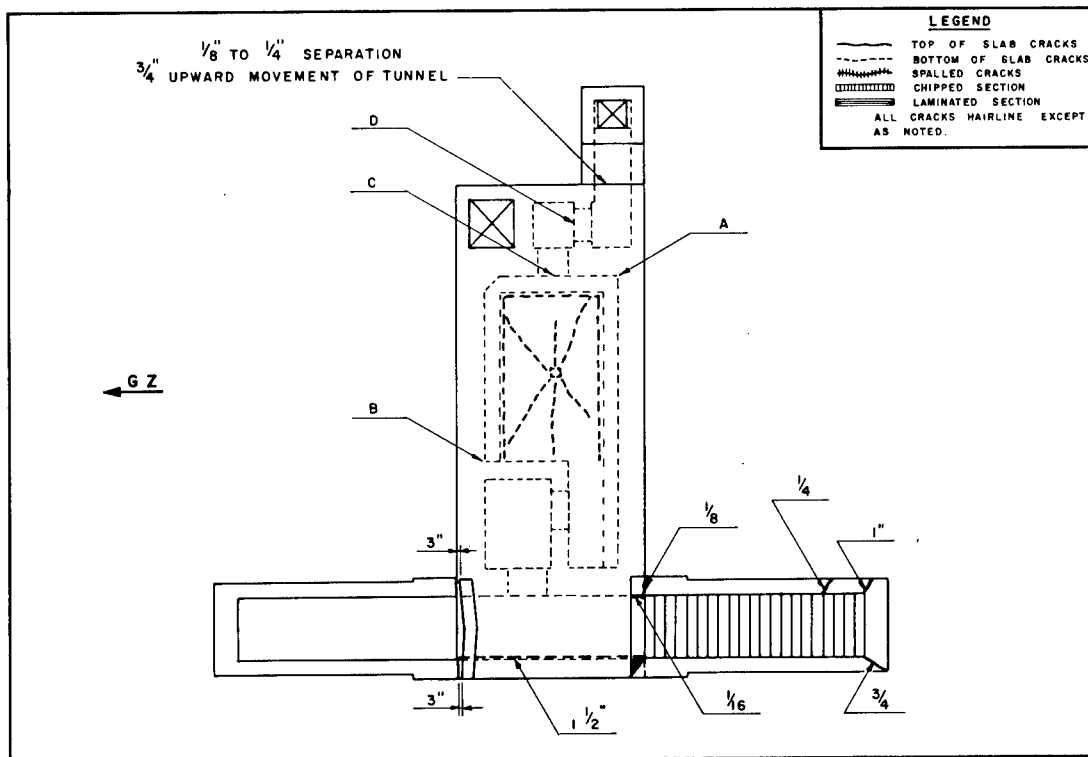
Fig. 3.25—Roof-slab crack pattern (structure RAb).

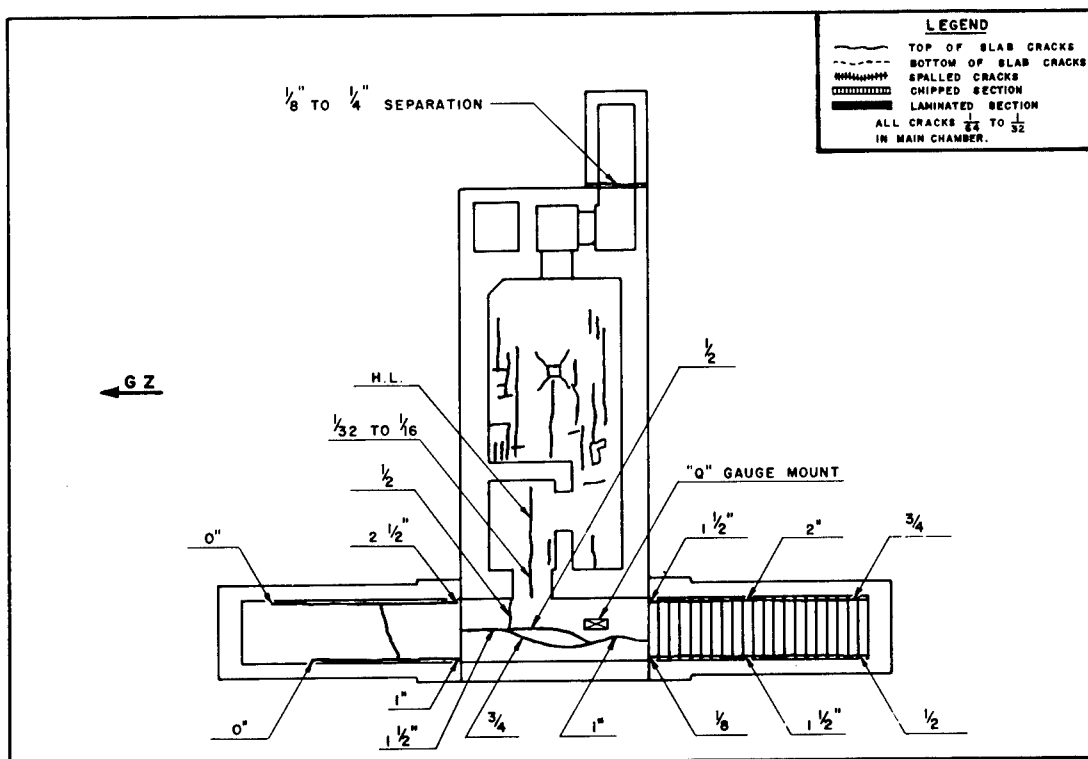
Fig. 3.26—Floor-slab crack pattern (structure RAb).

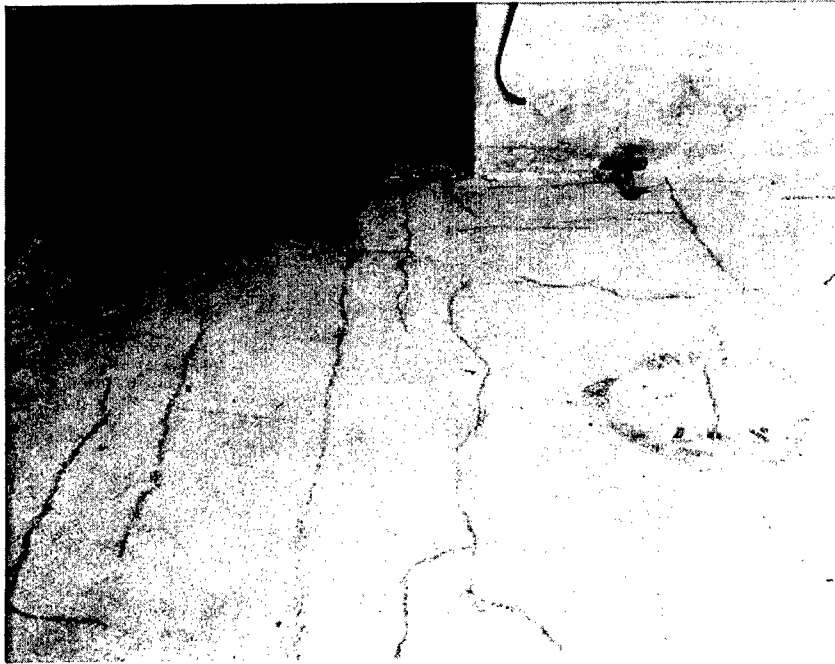
Fig. 3.28—Cracks in floor slab of main chamber, looking toward main entrance (structure RAb).

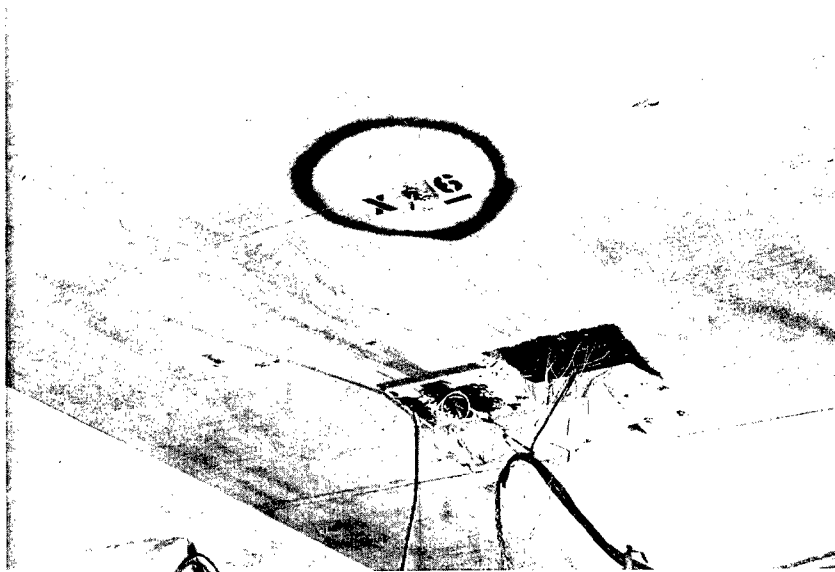
Fig. 3.29—Cracks, strain-gauge recess, and survey point in roof slab of main chamber (structure RAb).

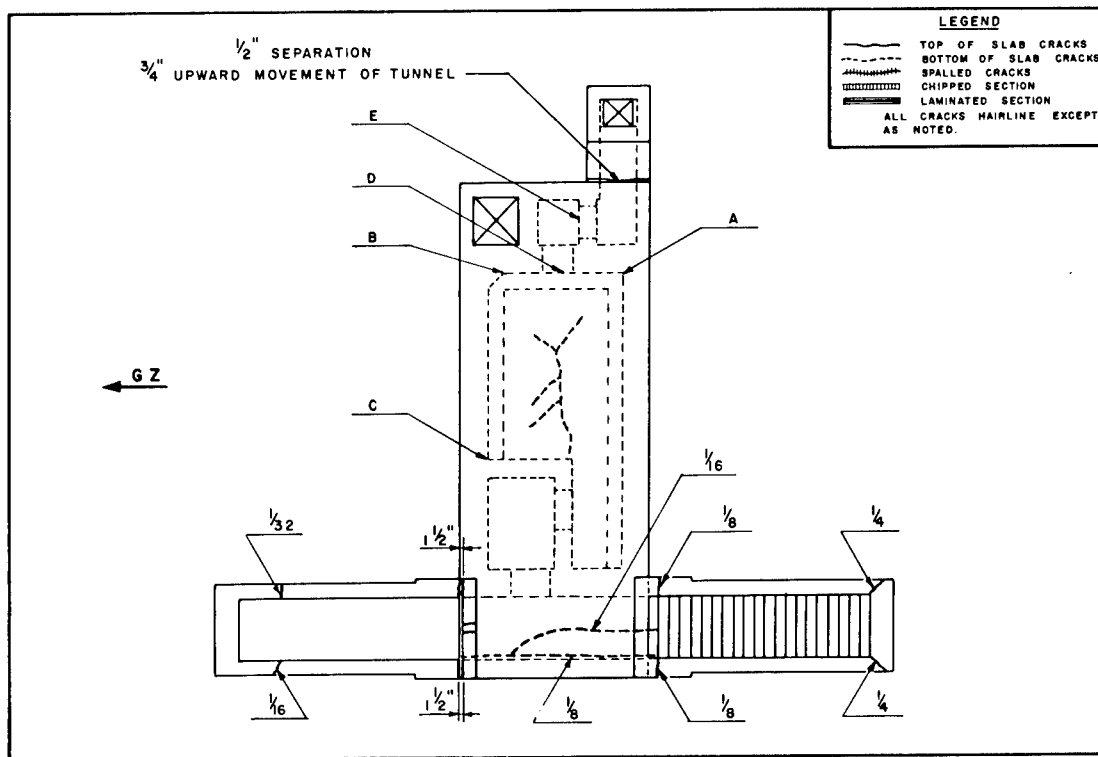
Fig. 3.33—Roof-slab crack pattern (structure RAc).

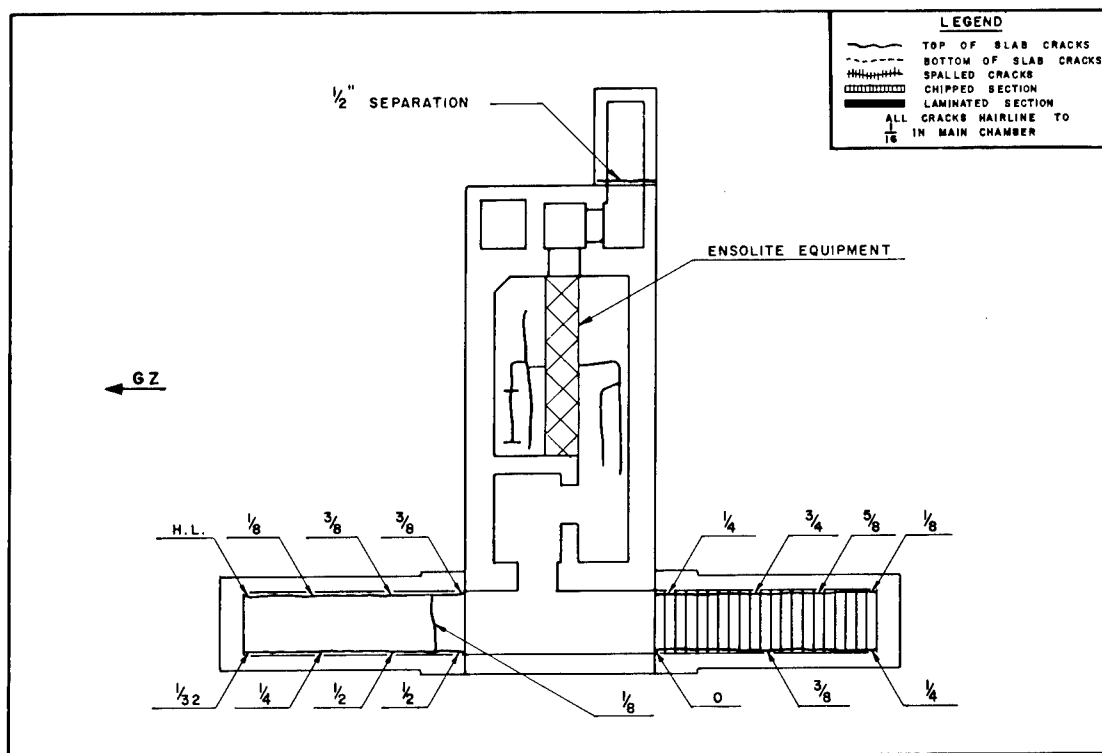
Fig. 3.34—Floor-slab crack pattern (structure RAc).

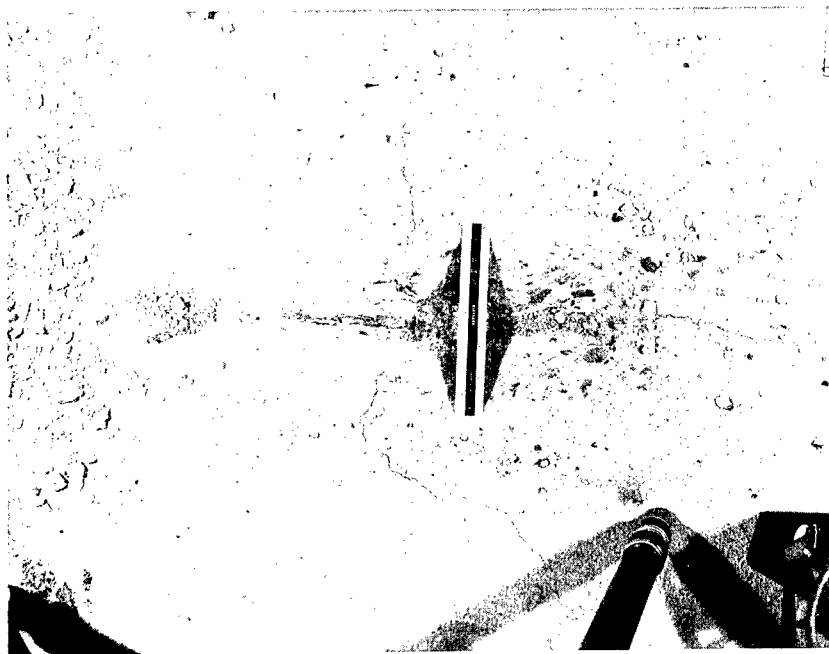
Fig. 3.38—Over-all view of chipped-out section with associated crack pattern (structure RAc).

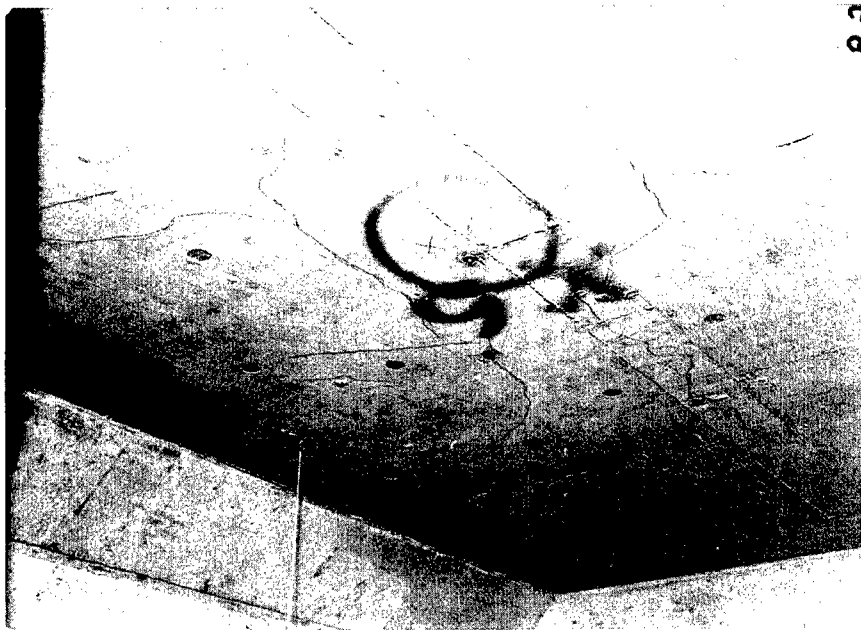
Fig. 3.43—Cracks in roof slab of main chamber (structure RAc).

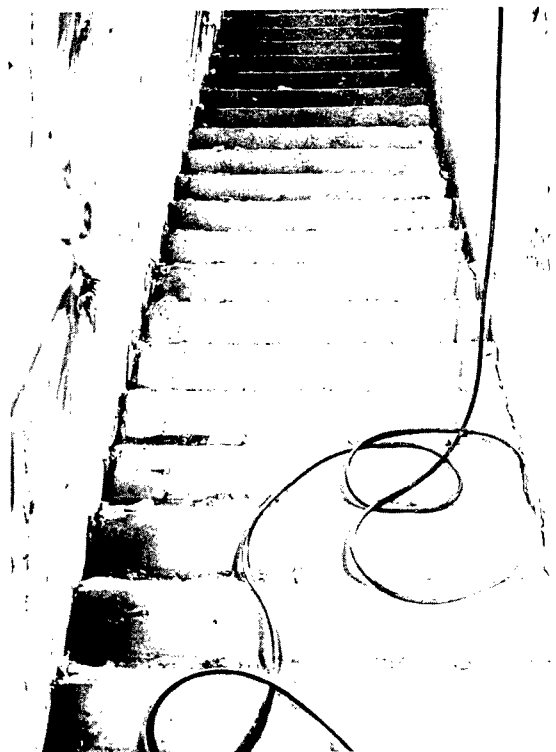
Fig. 3.46—Looking up stairs facing away from GZ, showing separations between stairs and interior and entrance walls (structure RAc).

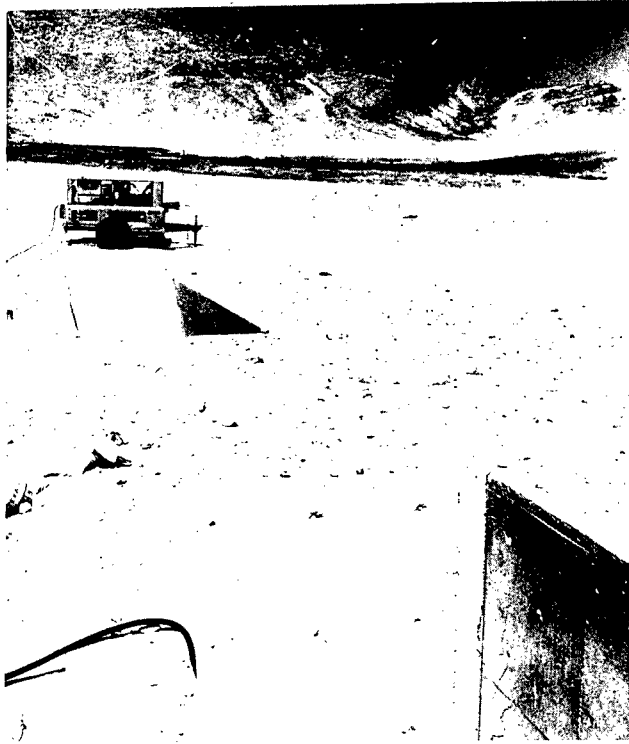
Fig. 3.48—Detail of cracks at intersection of parapet wall and interior wall and entrance facing away from GZ (structure RAc).

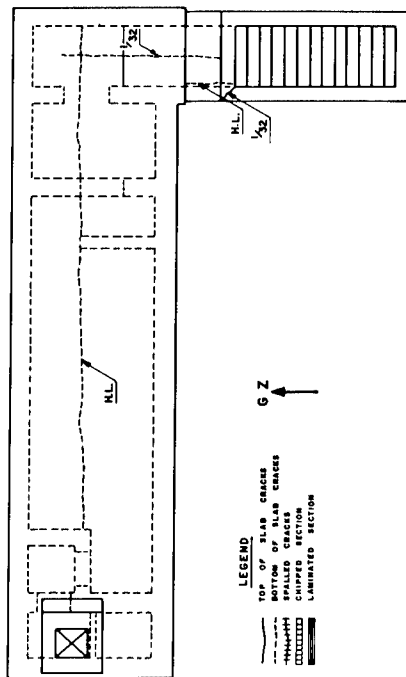
Fig. 3.58—Roof-slab crack pattern (structure CAa).

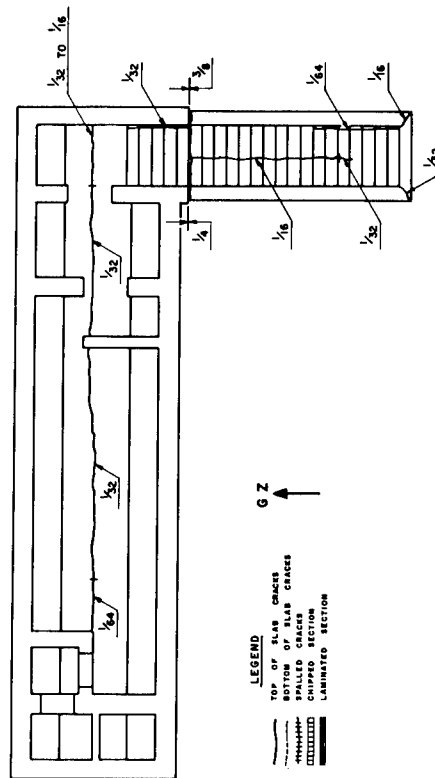
Fig. 3.59—Floor-slab crack pattern (structure CAa).

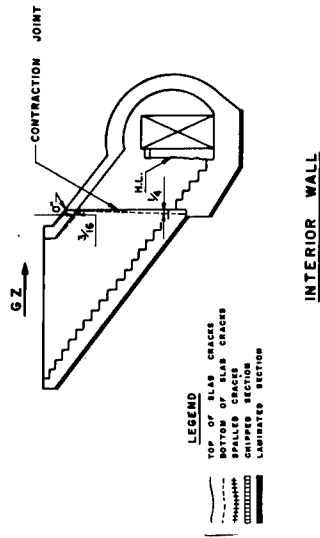
Fig. 3.60—Entrance crack pattern (structure CAa).

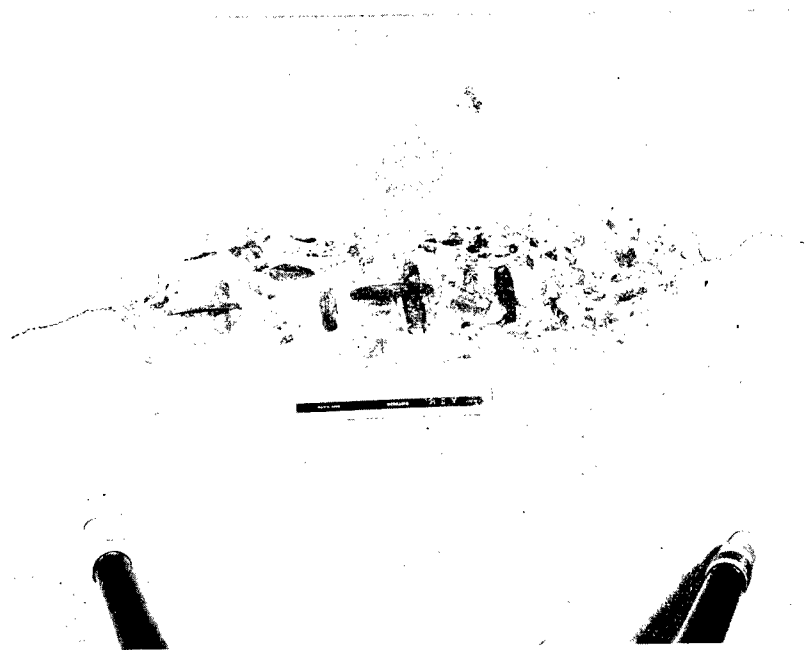
Fig. 3.61—Over-all view of chipped-out section with associated crack pattern (section CAa).

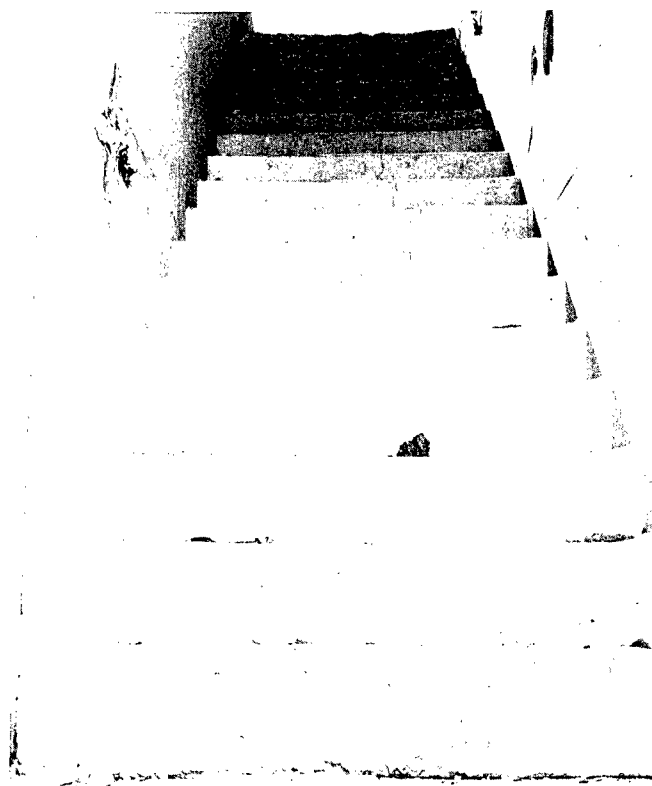
Fig. 3.71—Looking up stairs facing away from GZ (structure CAa). Note crack running up stairs and separation of construction joint.

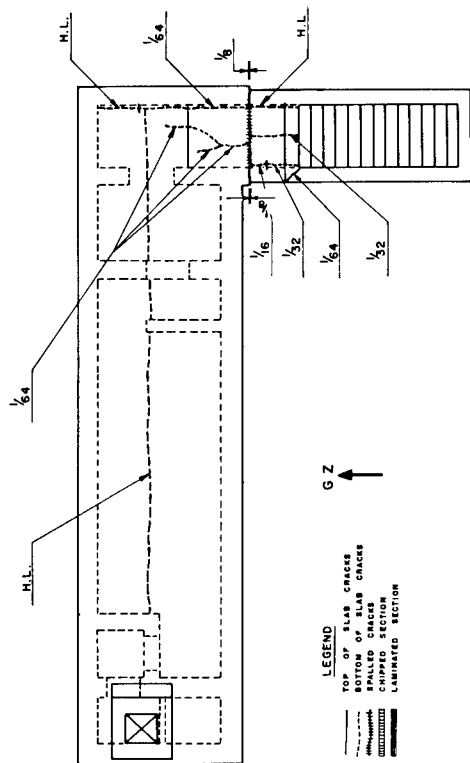
Fig. 3.73—Roof-slab crack pattern (structure CAb).

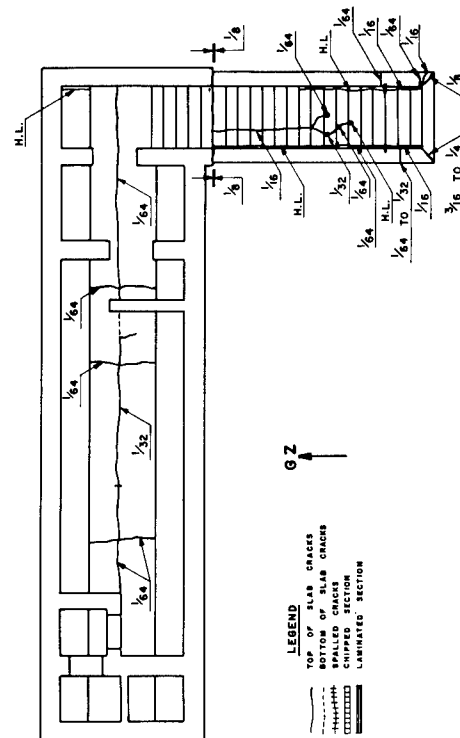
Fig. 3.74—Floor-slab crack pattern (structure CAb).

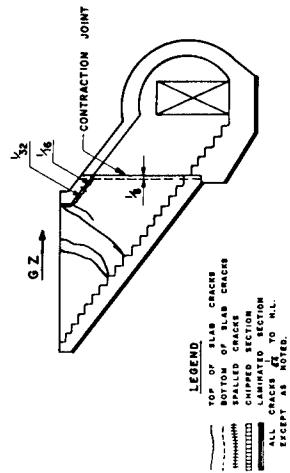
Fig. 3.75—Entrance crack pattern (structure CAb).

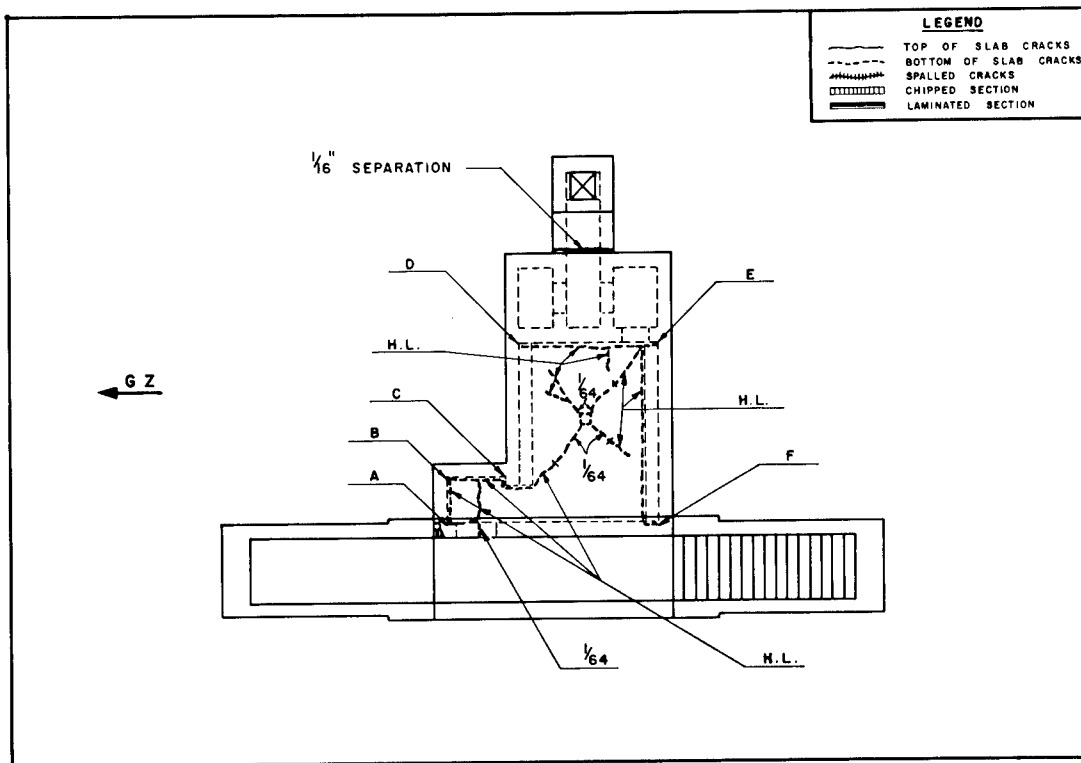
Fig. 3.82—Roof-slab crack pattern (structure RCa).

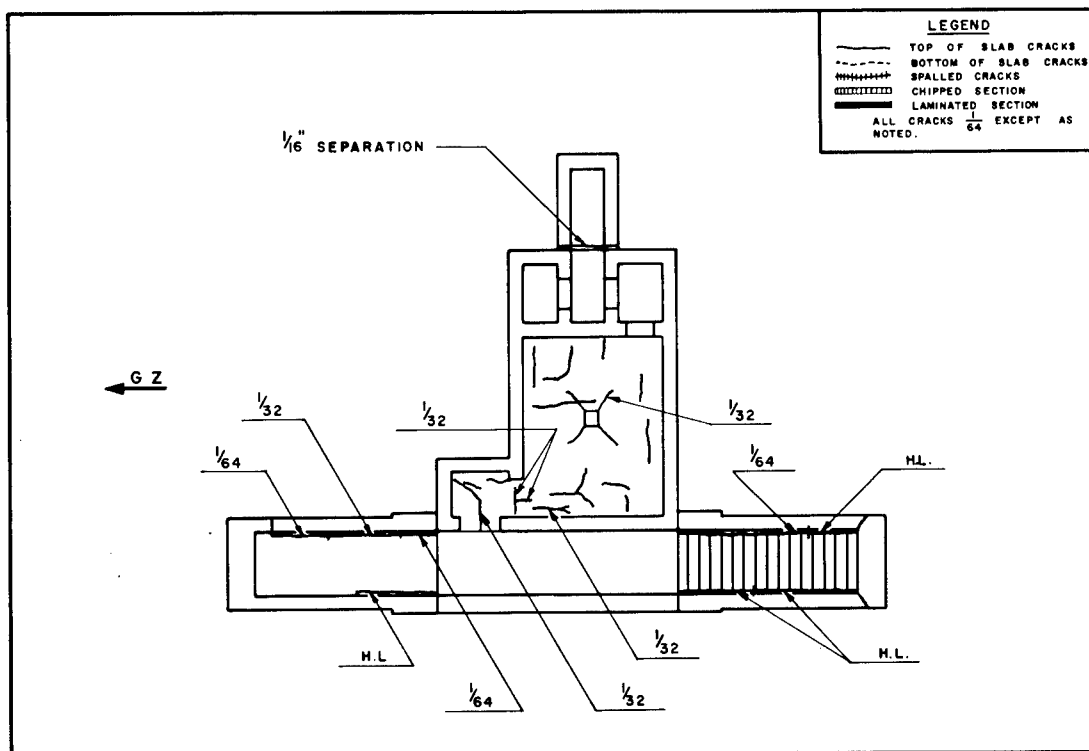
Fig. 3.83—Floor-slab crack pattern (structure RCa).

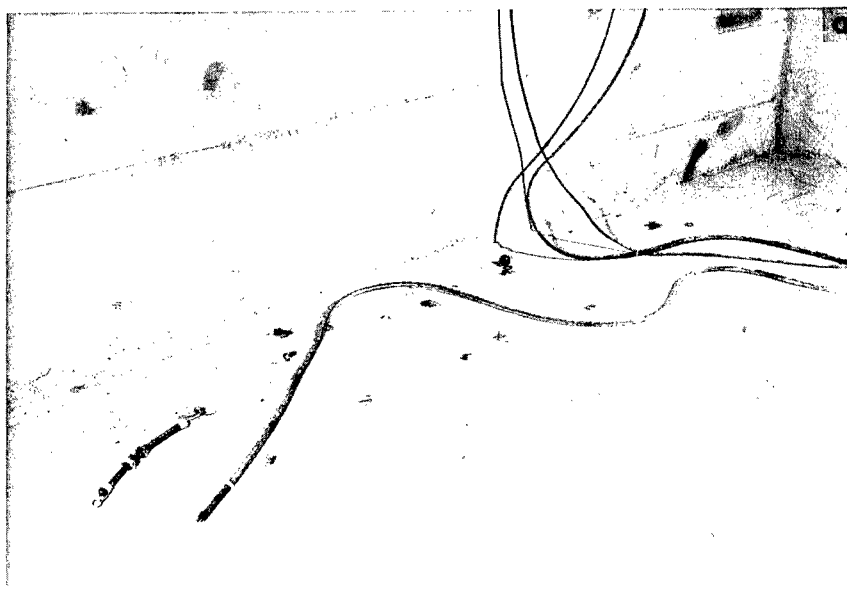
Fig. 3.85—Cracks in floor slab of main chamber looking toward emergency-exit corner of wall nearest GZ (structure RCa).

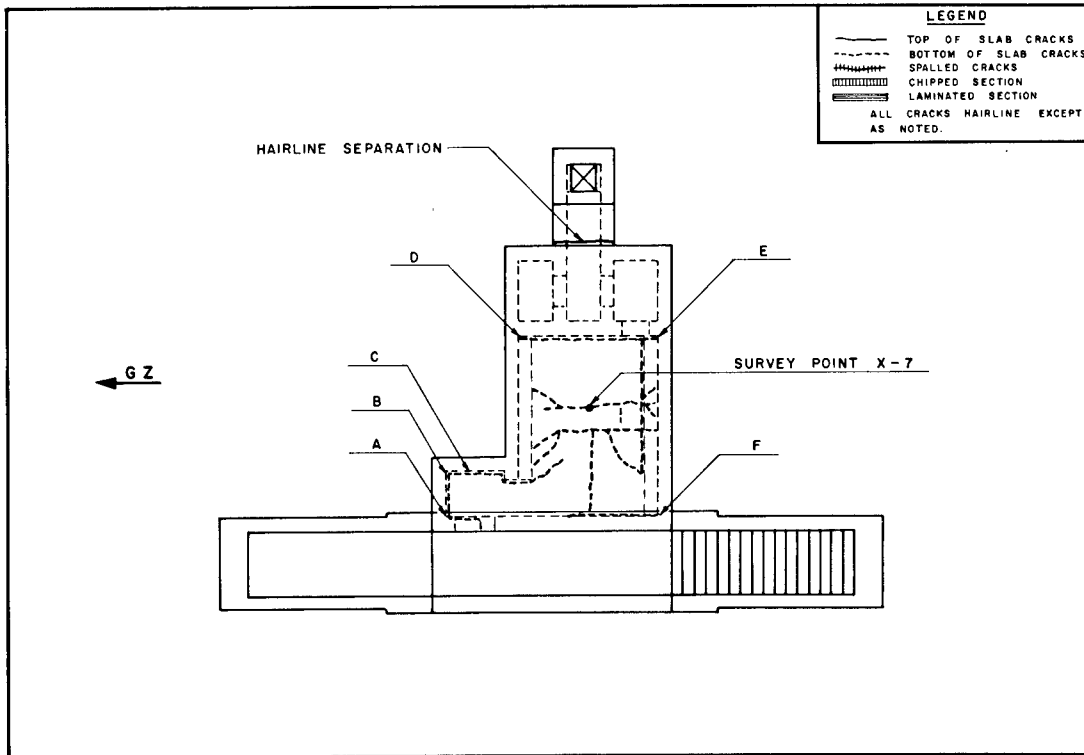
Fig. 3.92—Roof-slab crack pattern (structure RCb).

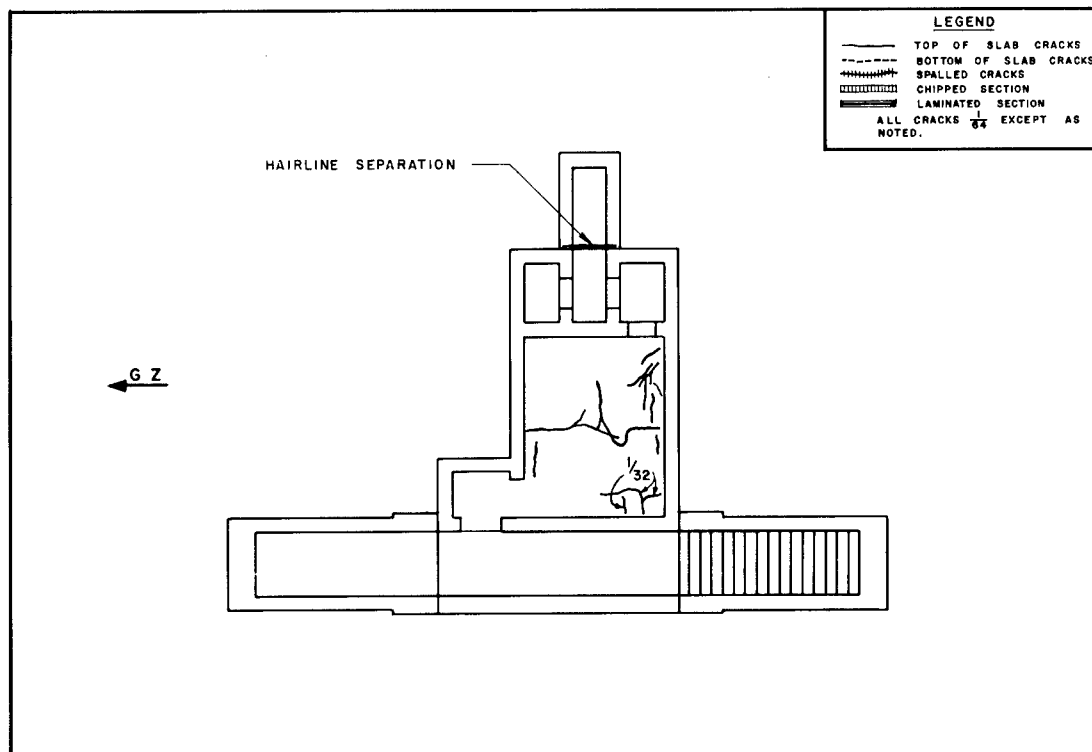
Fig. 3.93—Floor-slab crack pattern (structure RCb).

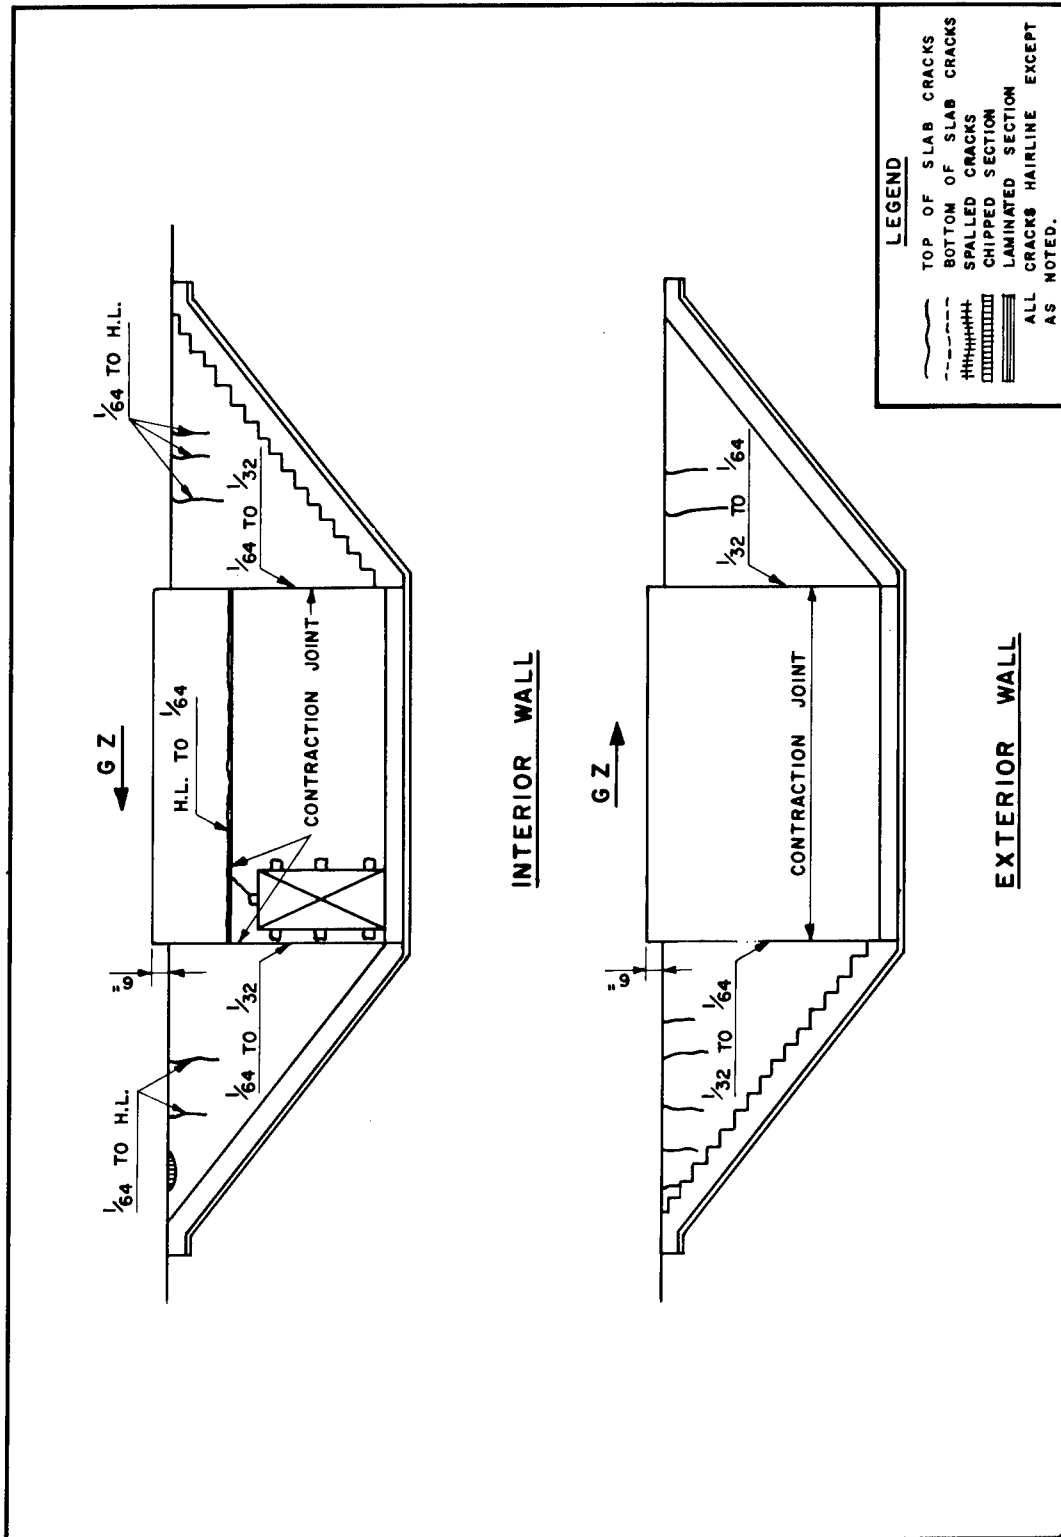
Fig. 3.94—Entrance crack pattern (structure RCb).

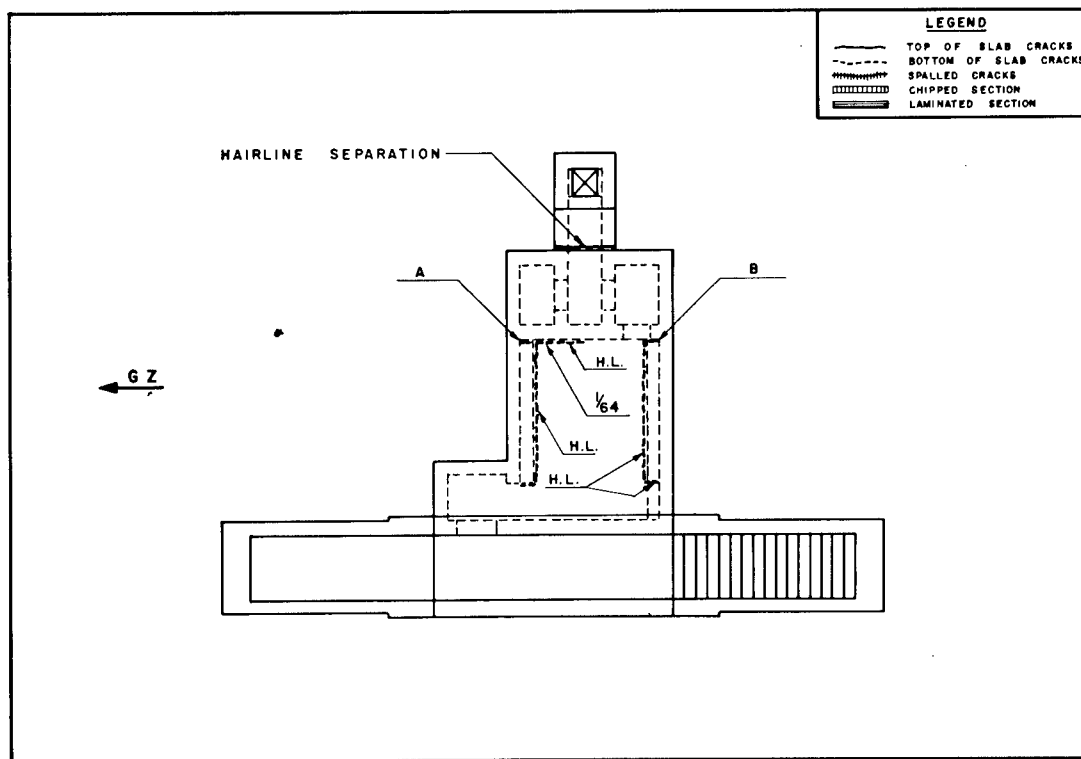
Fig. 3.99—Roof-slab crack pattern (structure RCc).

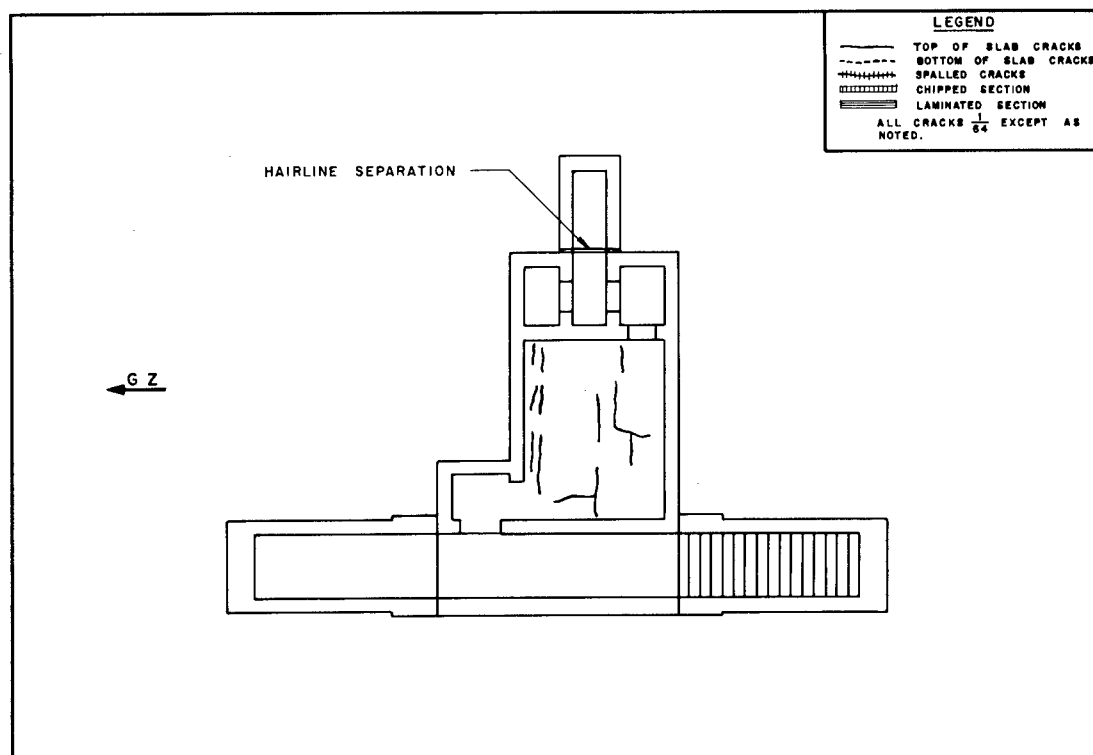
Fig. 3.100—Floor-slab crack pattern (structure RCc).
